MARSHWOOD DAM

NDI ID No. PA-00365
DER ID No. 35-88

⑥ PHASE I INSPECTION REPORT

① Number 12 1052 Number
NATIONAL DAM INSPECTION PROGRAM. Marshwood Dam
(NDI ID PA-00365, DER ID 35-88), Susquehanna River
Basin, Little Roaring Brook, Lackawanna
County, Pennsylvania

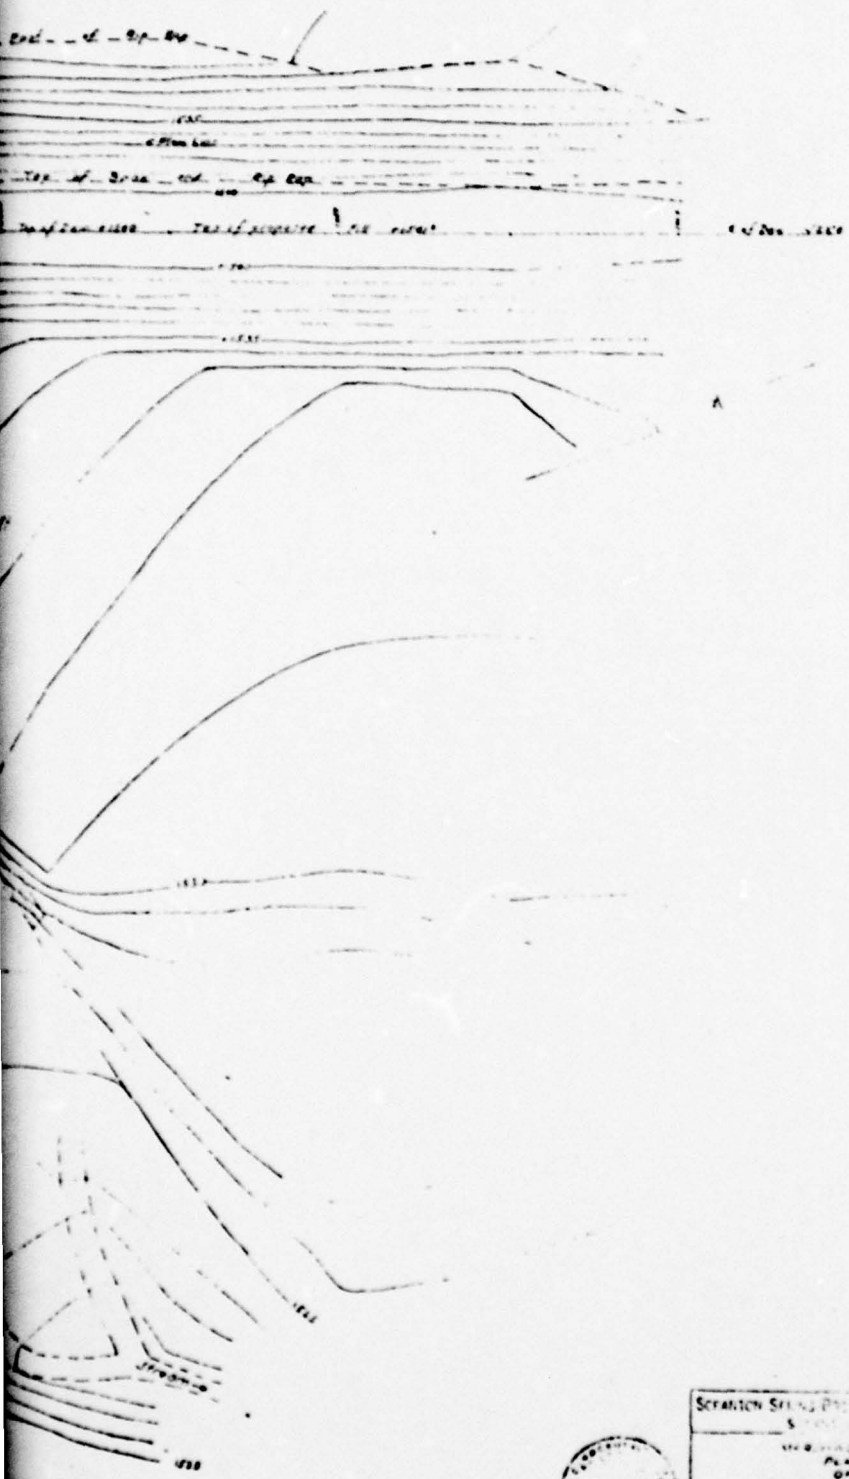
PHASE I INSPECTION REPORT
NATIONAL DAM INSPECTION PROGRAM
MARSHWOOD DAM
PENNSYLVANIA GAS AND WATER COMPANY
SOUTH EMBANKMENT
AND SPILLWAY
FEBRUARY 1979
PLATE 2

(2) South Embankment. Brush and trees growing on the embankment and at the toes are undesirable. Because of the brush, the inspection cannot be considered definitive. Plate 2 indicates that the left abutment is about 250 feet from the spillway. Plate 5 indicates that it is over 300 feet from the spillway. From the data collected during the field inspection, Plate 5 appears to be more correct. Plate 5 and the survey information in Appendix B also indicate that the lower portion of the downstream slope is LV on 10H. Plate 2 does not show this slope. The gouge in the upstream slope leaves the embankment with a reduced topwidth and no upstream slope protection. The Owner described this area as looking like a game trail; he stated, however, that it was too large for a game trail. Ice action or vandalism could both be causes of the gouge. Except at the gouge, the low areas are probably caused by settlement.

(3) Repair the gouge on the South Embankment.
